**Project Title:** Knowle Lane, Cranleigh

**Project No/ Document Reference:** A423 – TN002

## Surface Water Off Site Drainage Connectivity

Title  
**OFF SITE DRAINAGE CONNECTIVITY**

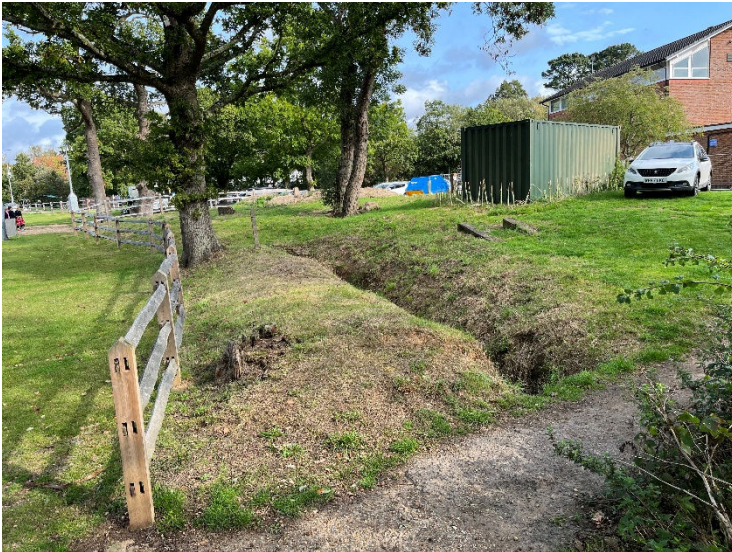
Photo 1: Looking North

- 2.2. The ditch in question diverts away from the playing fields opposite Snoxhall Community Centre as shown in **Photo 1**.
- 2.3. Flow continues via a culvert beneath the Snoxhall Fields access road/track before heading north in a ditch on the eastern side of the track, see **Photo 2**.

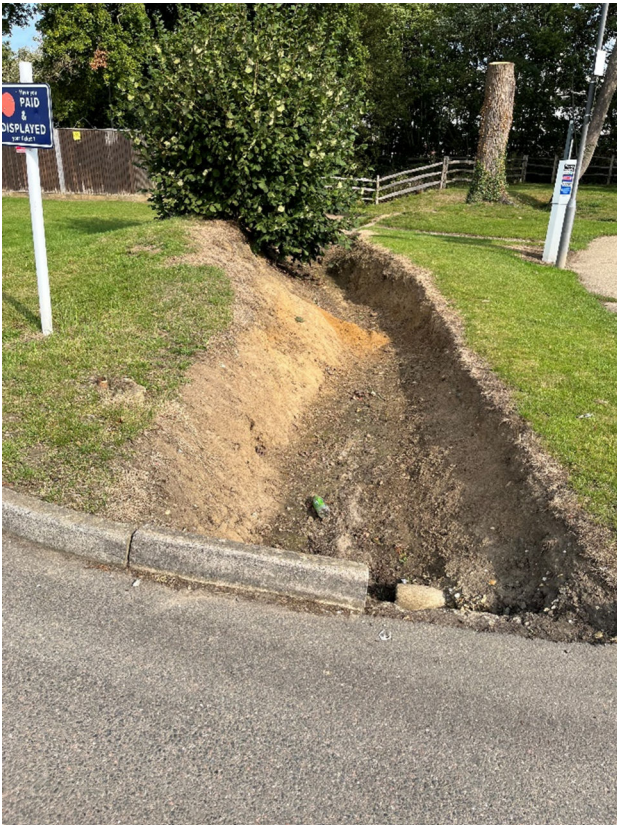
Photo 3: Looking North East

- 2.4. This ditch then heads northeast via a further culvert beneath the car park access and to the rear of the existing sub-station, see **Photos 3 and 4**.

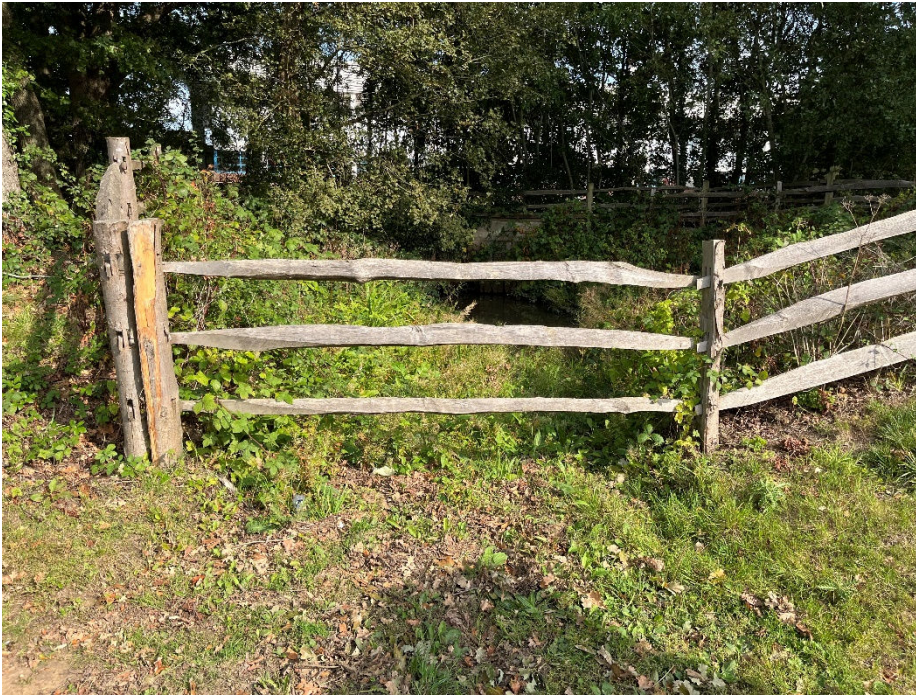
Photo 5: Looking North East

- 2.5. This ditch then opens out before entering a ponded area upstream of a culverted link to the main watercourse running along the southern boundary of Cranleigh Leisure centre. **See Photo 5**.

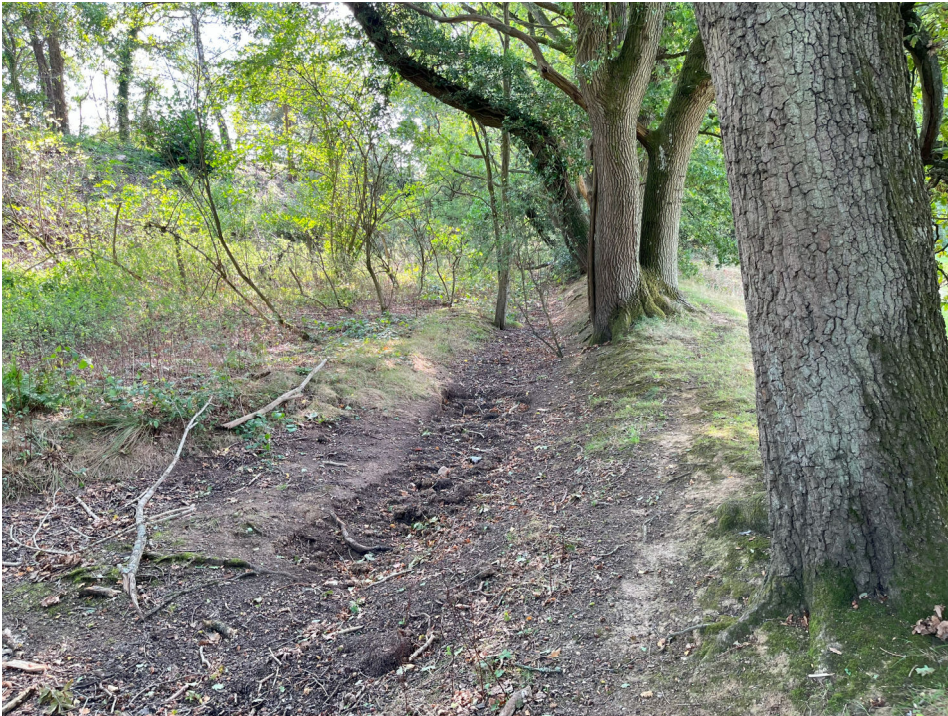
Photo 6: Looking South

- 3.1. The outfall for the Southern catchment is located within a wooded area to the south of the Site and west of the Downs Link cycle route. The ditch at the outfall location is wholly within the applicant's ownership and wholly within the Planning Application red line.
- 3.2. The ditch in question heads east for a short length before turning south. Refer to drawing A423-SK-001 for details.
- 3.3. This ditch continues south towards the main watercourse following the prevailing north to south fall of the land. **See Photo 6.**
- 3.4. The ditch ends at a headwall with the pipe heading in a south easterly direction towards the main watercourse.
- 3.5. Drawing A423-SK-001 indicates these watercourses and connection points.

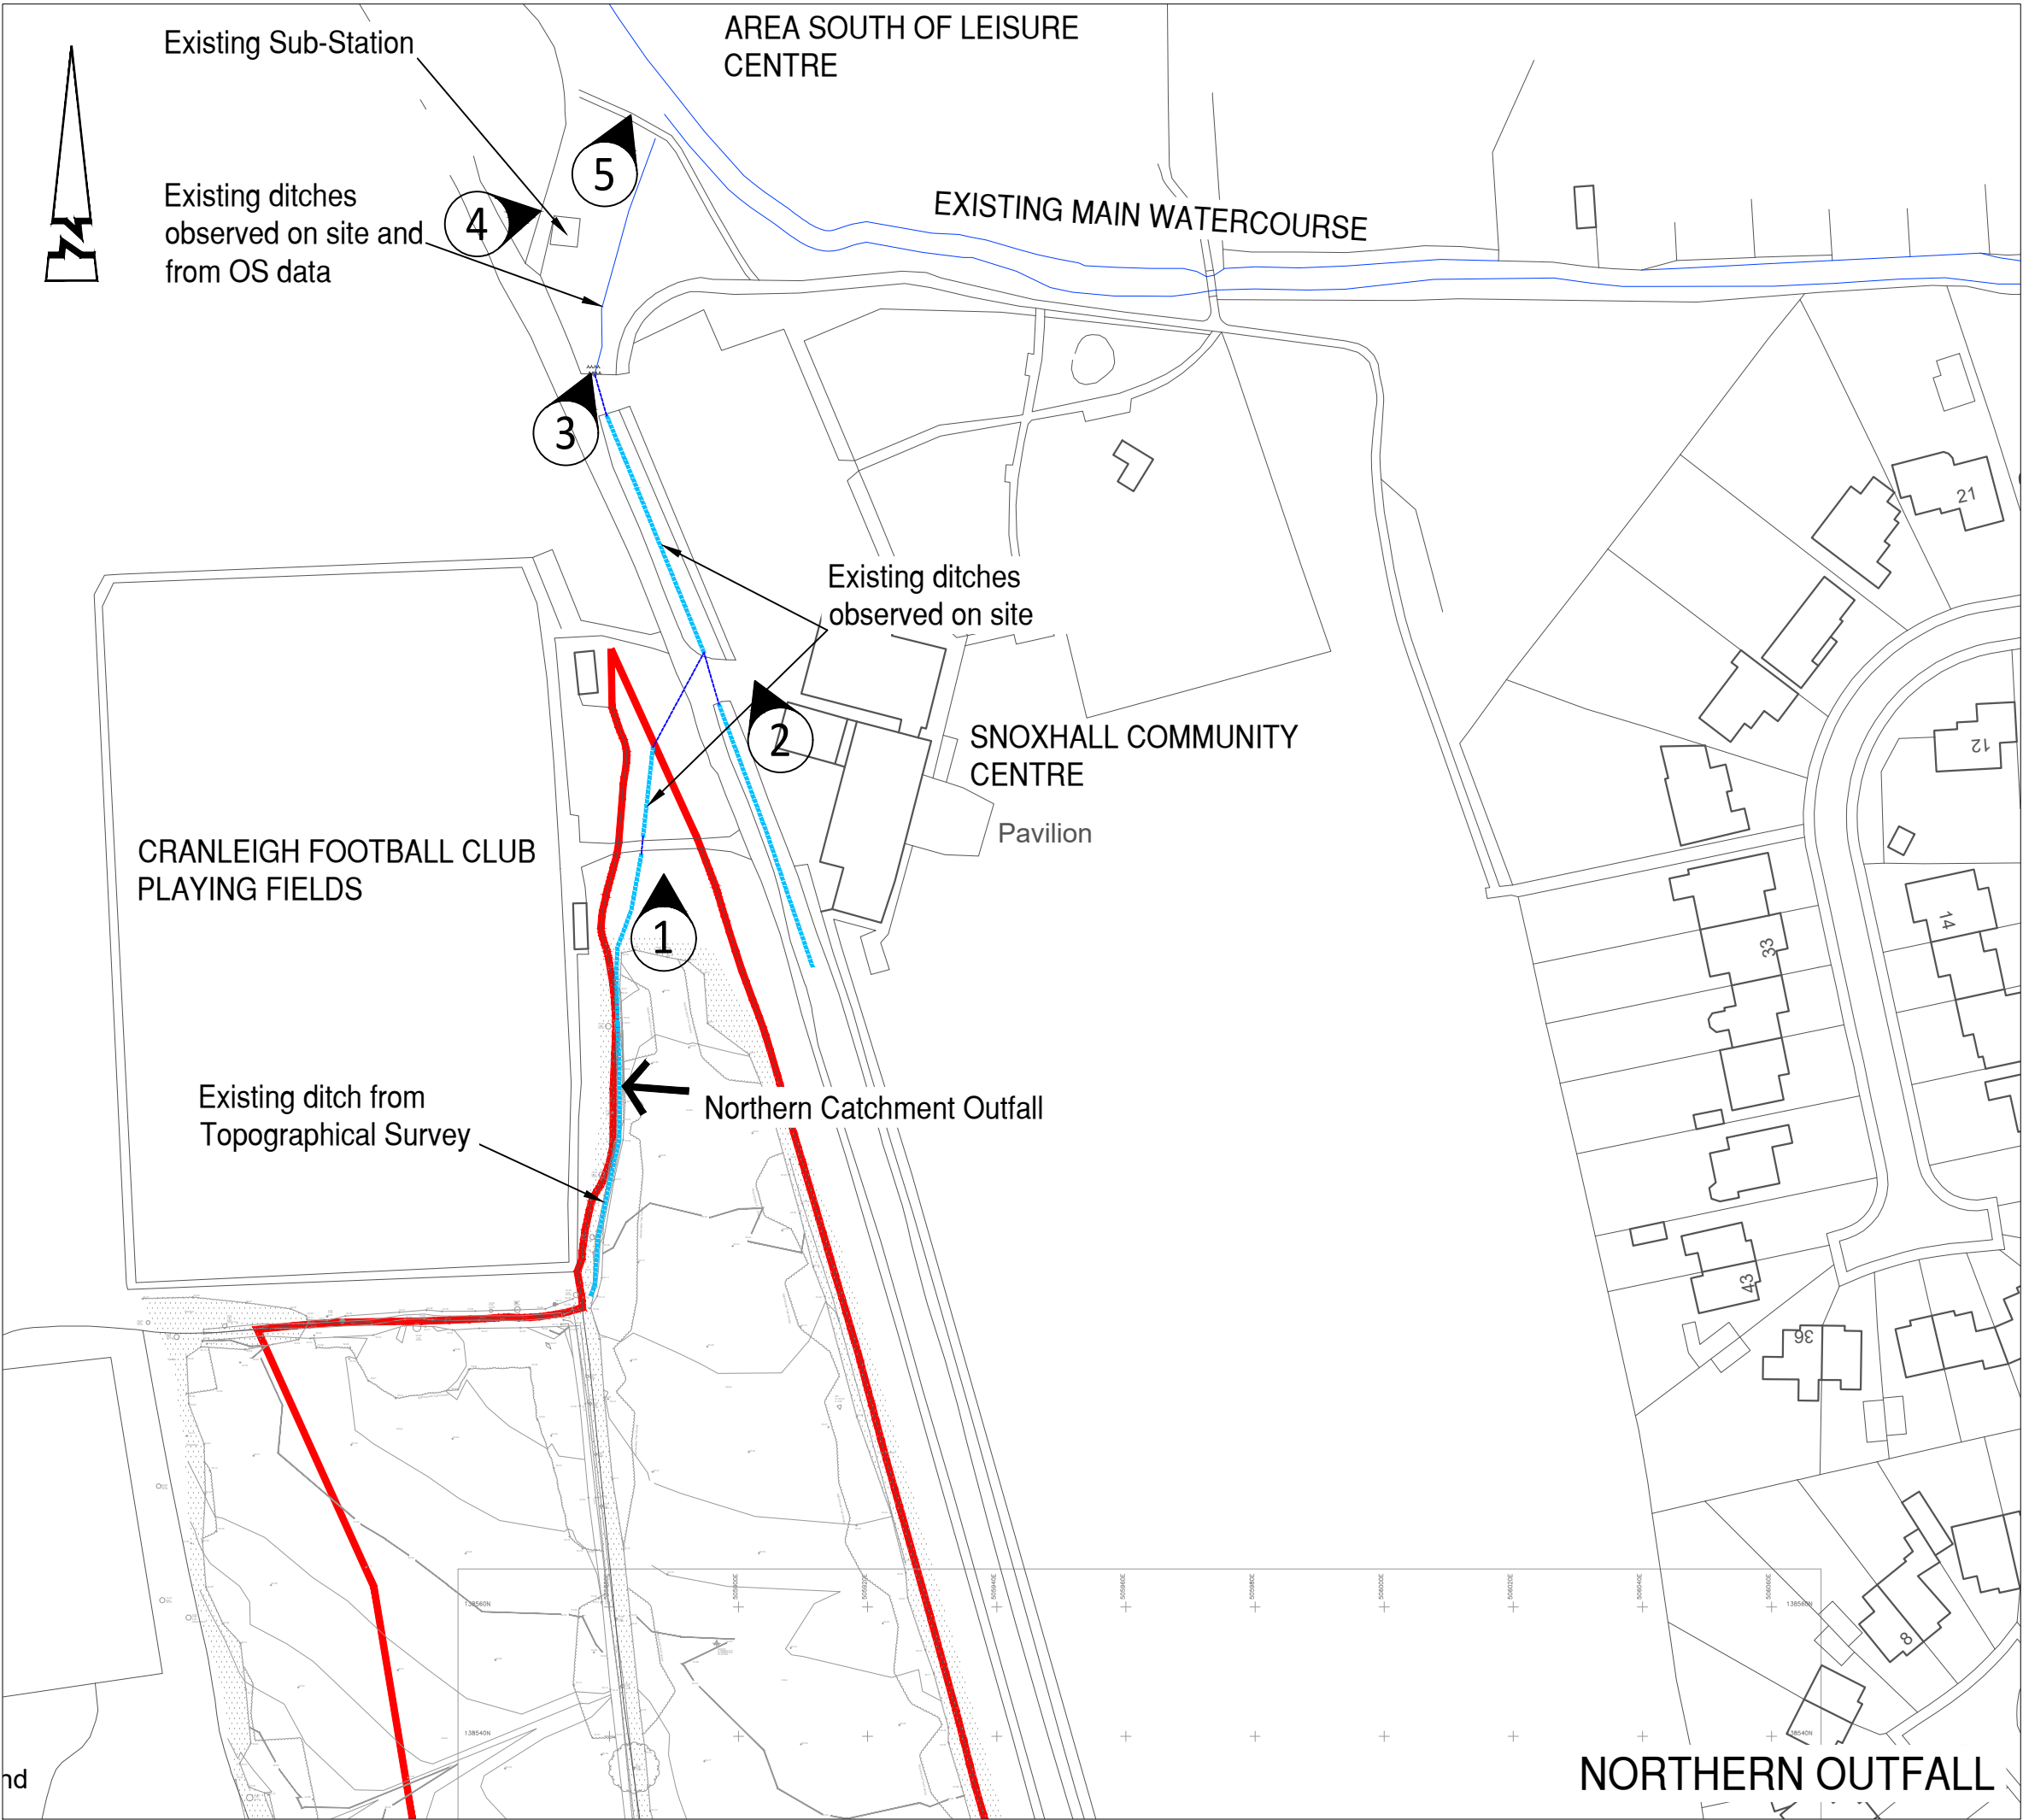
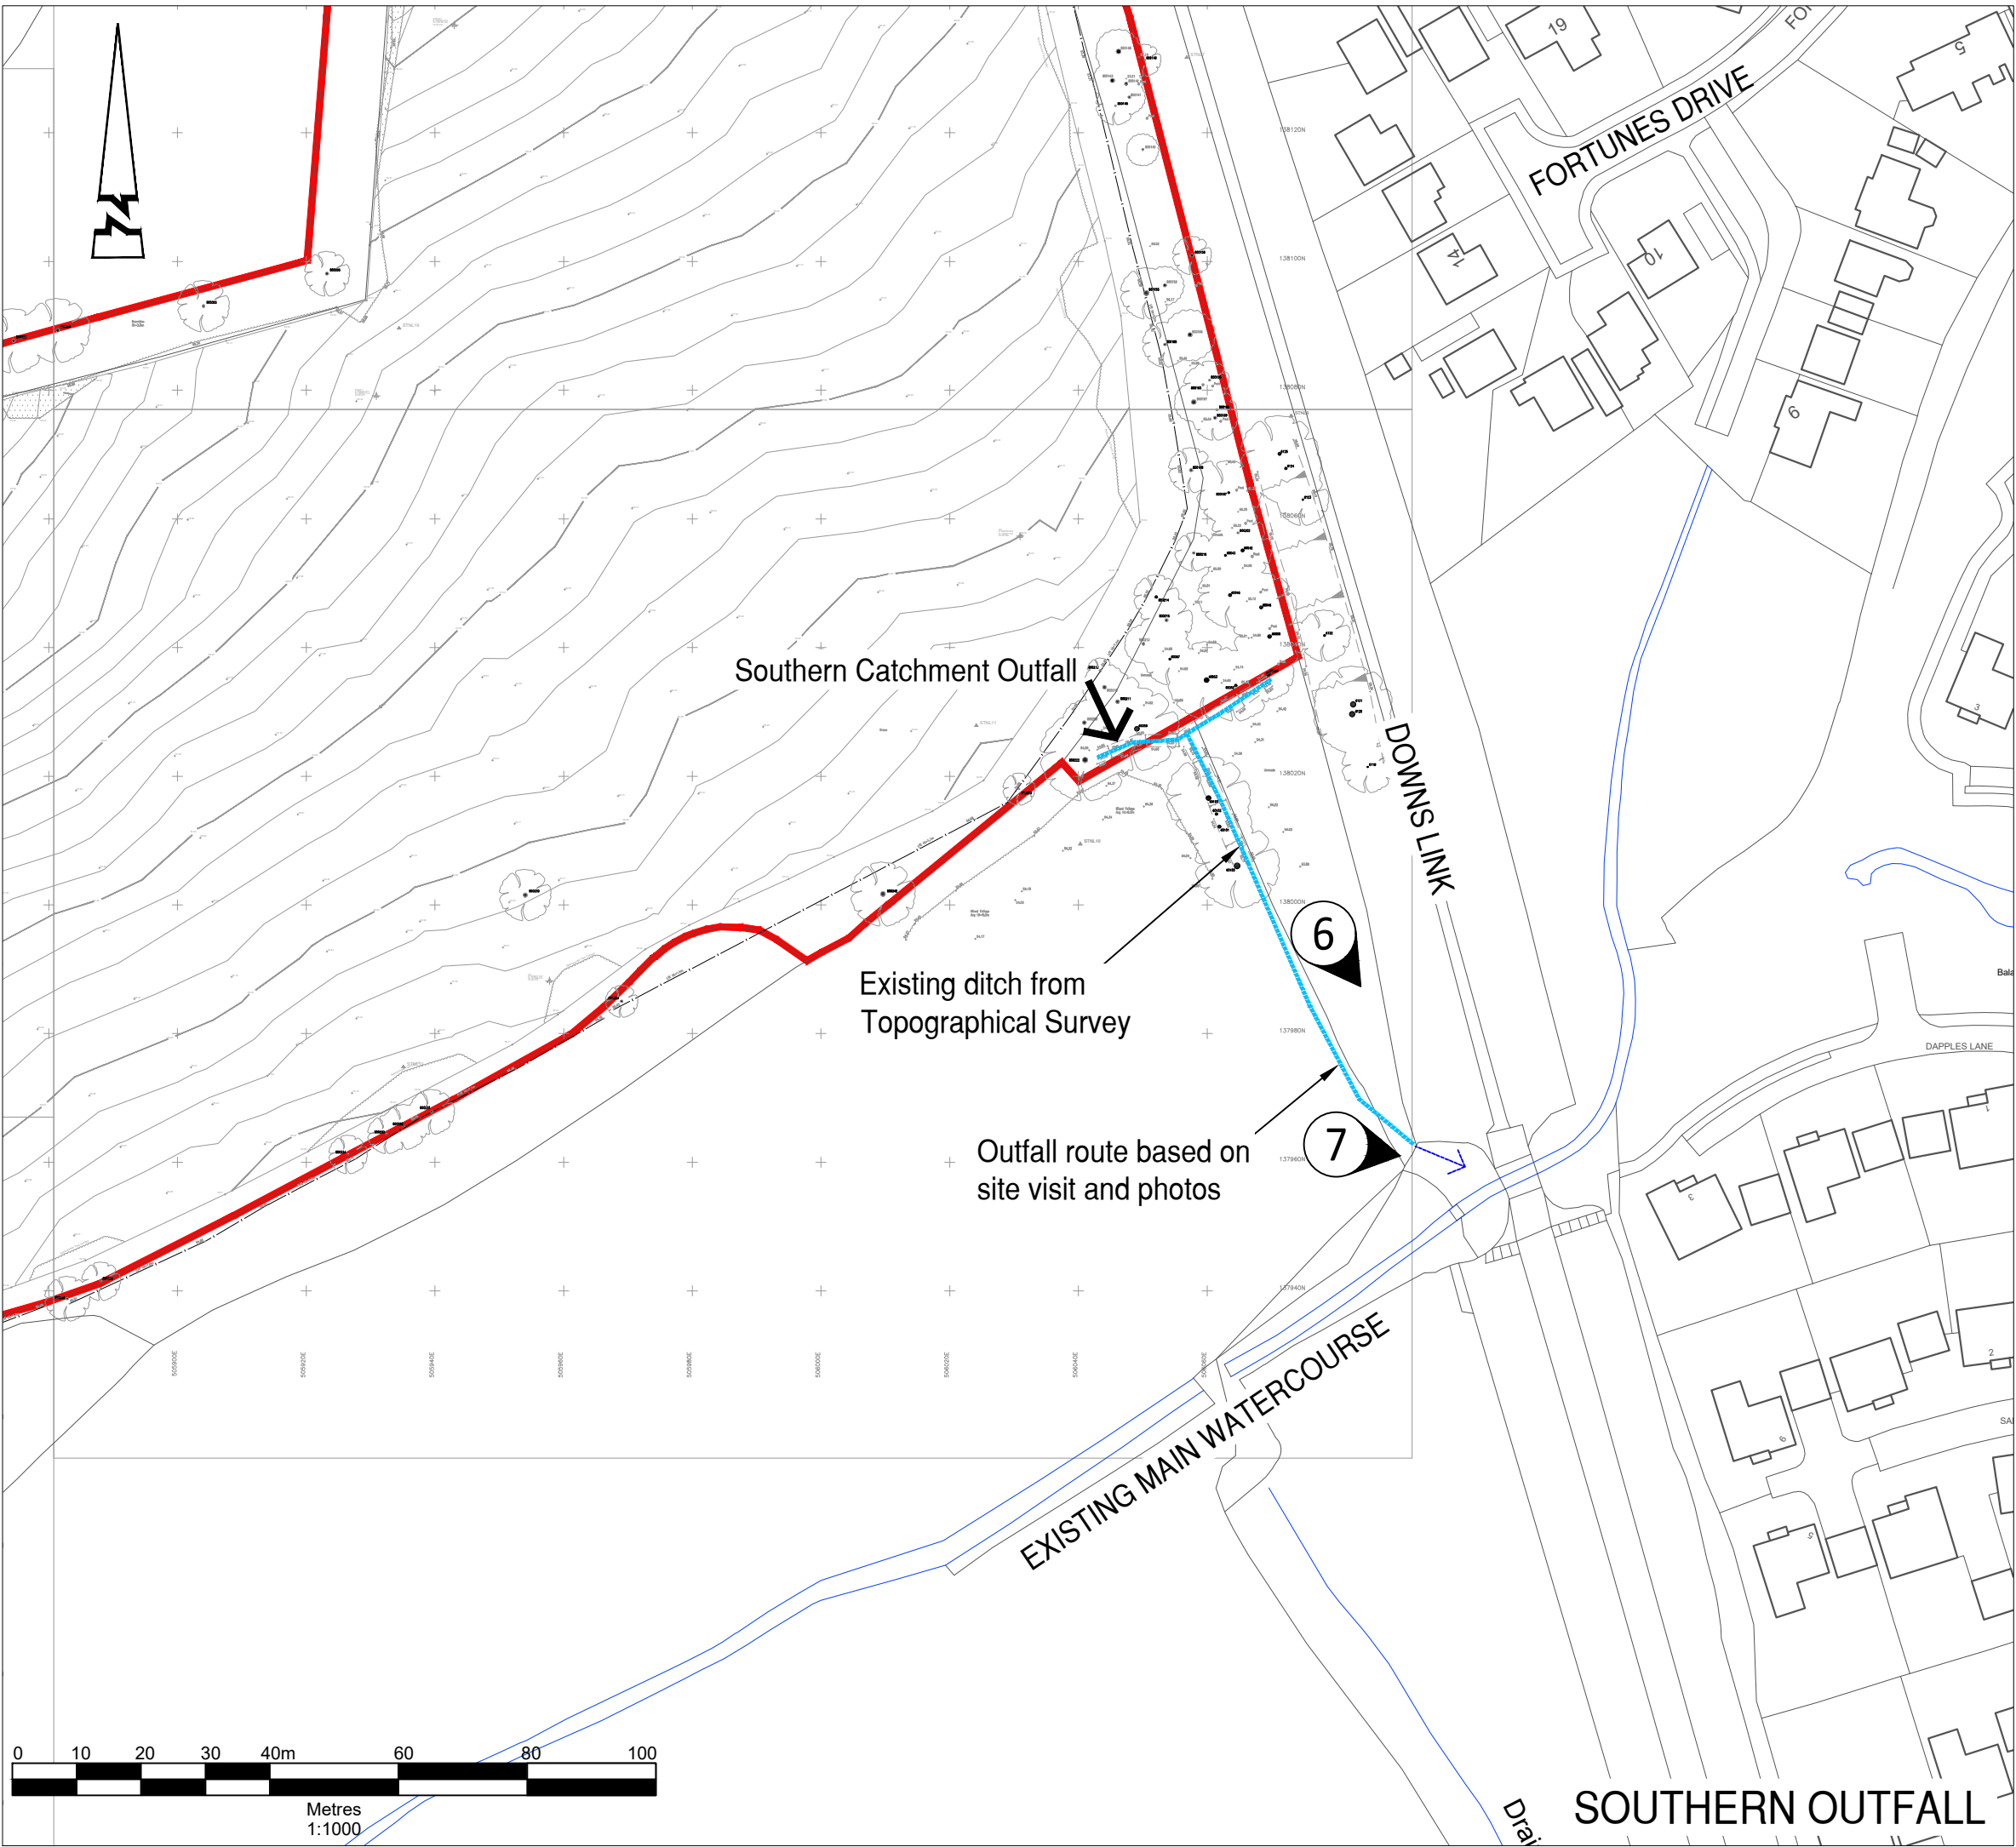
Drawing No  
A423-SK-001

- 2.6. Drawing **A423-SK-001** indicates these watercourses and connection points.
